BRITISH FIRE PREVENTION COMMITTEE.—No. 132.

# THE EFFECT OF FIRE.

THE PARKER BUILDING FIRE,

W. C. ROBINSON.

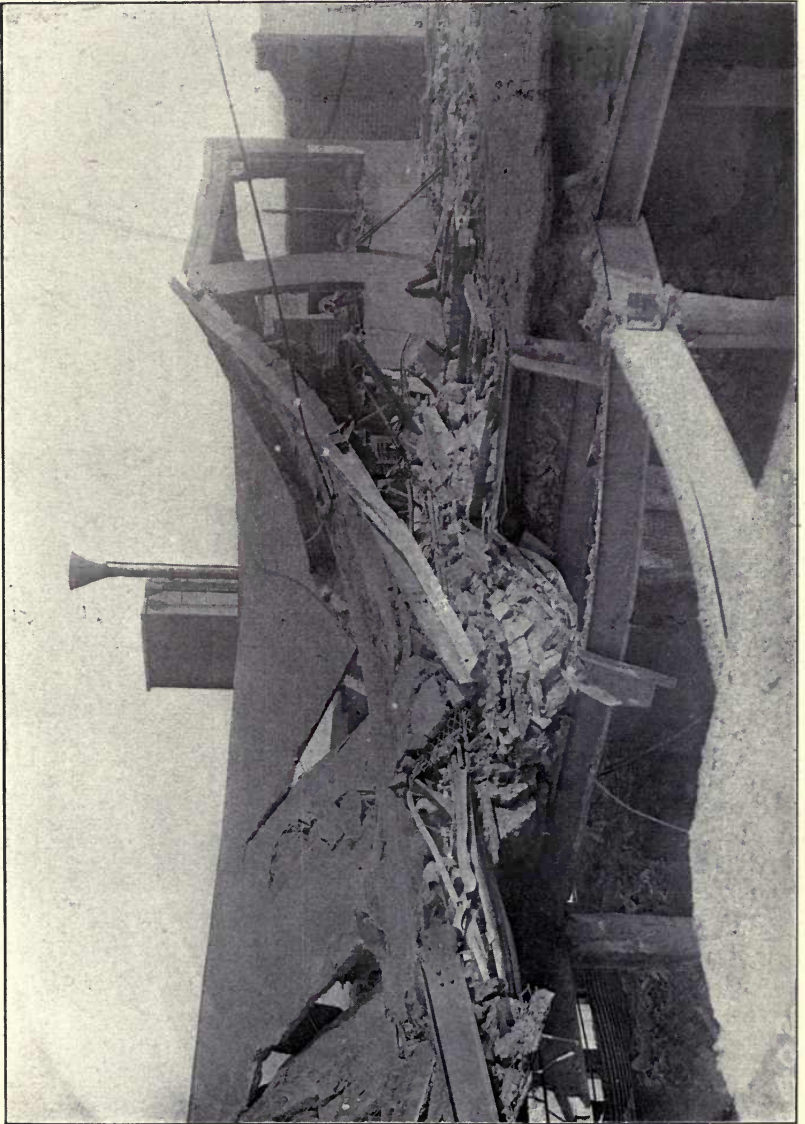
Roof, Looking Northeast, Showing Collapsed Roof-House and Depth of Fill Over Beams.

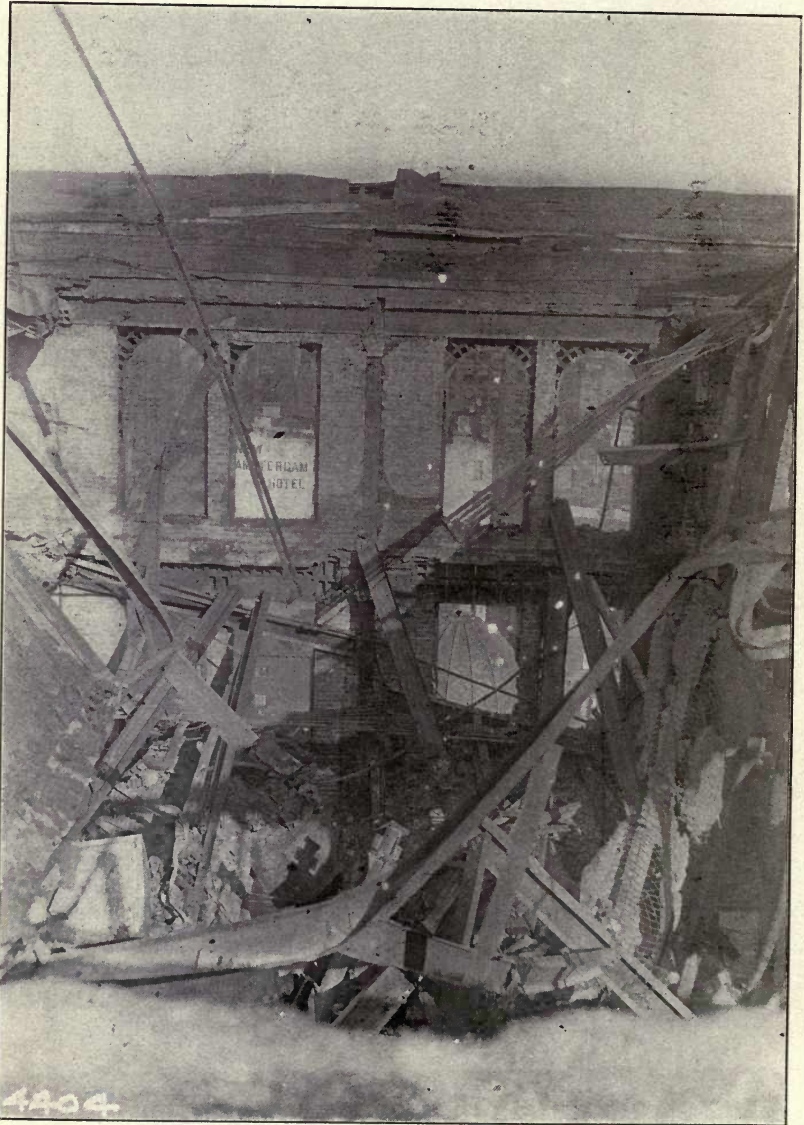
The failure of columns 33 and 34 caused the collapse of a section of the twelfth floor, roof and roof house approximately sixty feet long by thirty feet wide, and an adjoining section of the roof and twelfth floor, approximately fifteen by twenty feet. The falling material mostly lodged in the framing of the eleventh floor, large quantities of the tile arch blocks going through to lower stories and causing the failure of numerous arches by impact. (See floor plans and section.)

4404  
TWELFTH STORY, Looking North, Showing Collapsed Portion of Roof,  
Vicinity of Columns 33 and 34, Damaged Cornice, Exposed  
Wall Columns, etc.

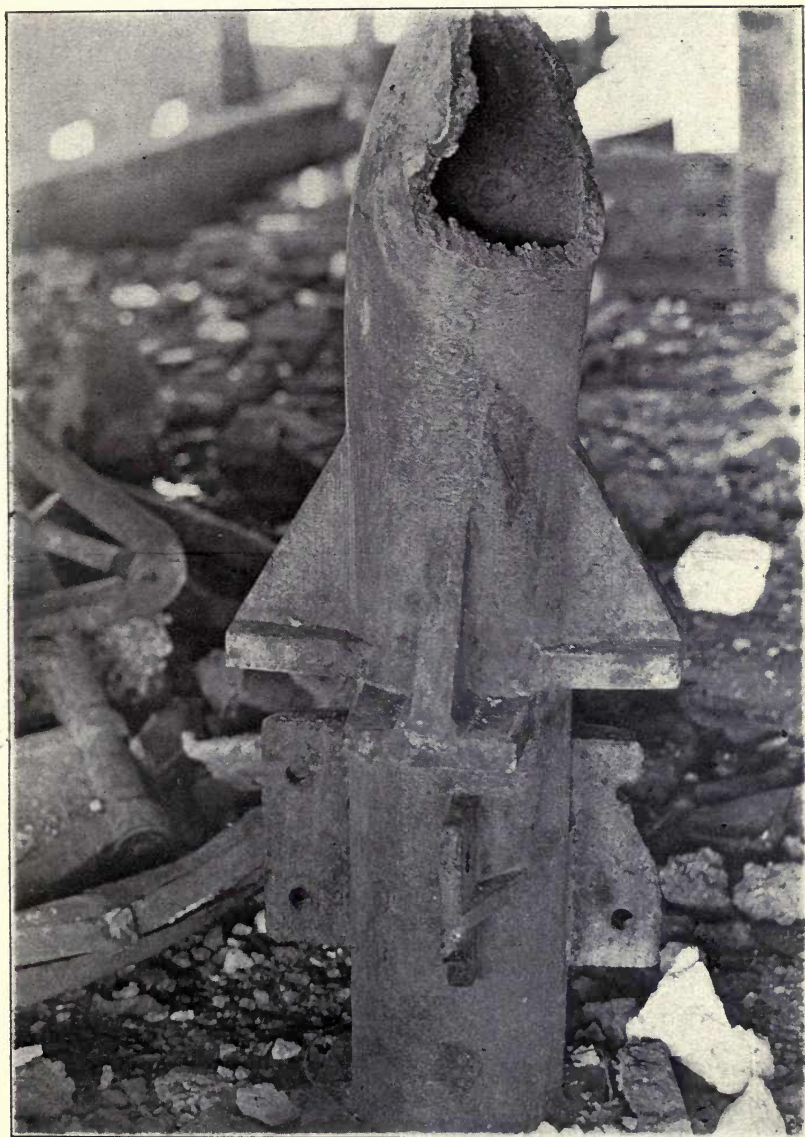
**Damage:** The cast iron columns were apparently uninjured except in and surrounding the collapsed areas and at one or two other points. The sixth story section of column 45 failed about four feet six inches below the seventh floor and the eleventh story sections of columns 33 and 34 failed about four feet below the twelfth floor level.

These failures were caused by heat, the columns being deflected and bulged at the points of fracture. (See Plates XX, XXI, XXIX, etc.)

Collapsed Column (33 or 34). Eleventh Story. Showing Fracture and Effect of Heat. View Inverted.

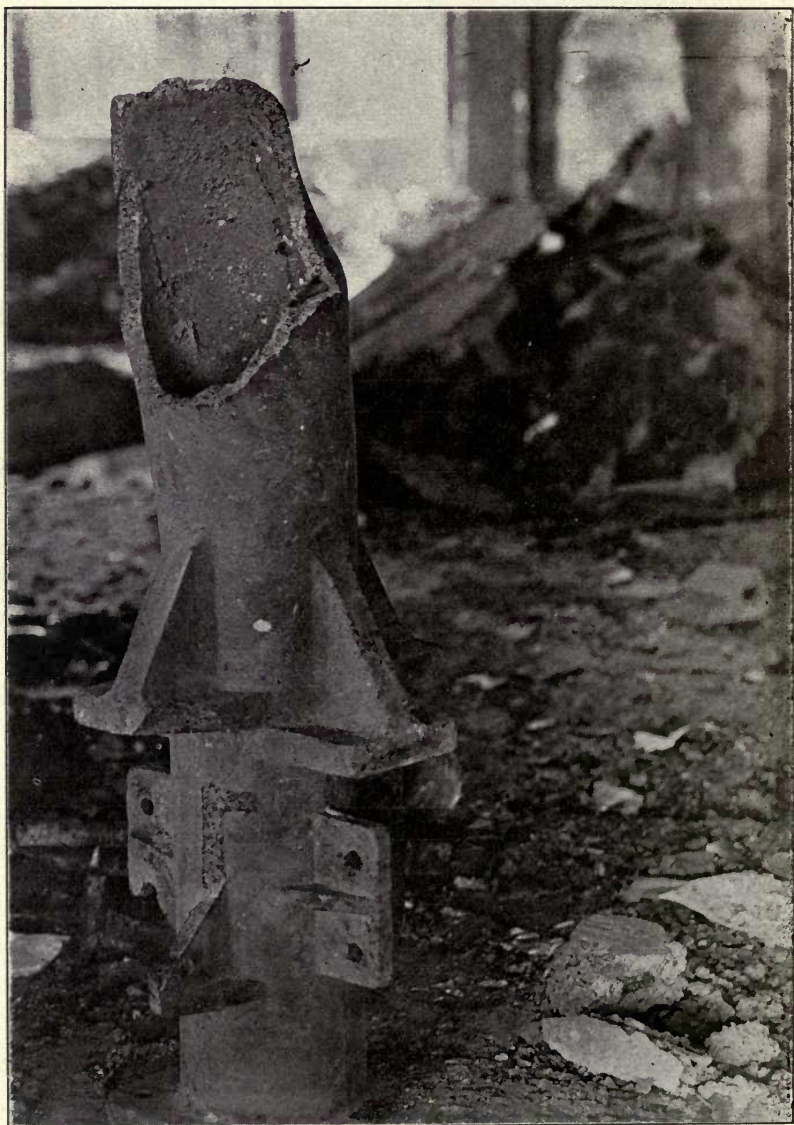
Collapsed Column (34 or 33), Eleventh Story, Showing Fracture and Effect of Heat. View Inverted.

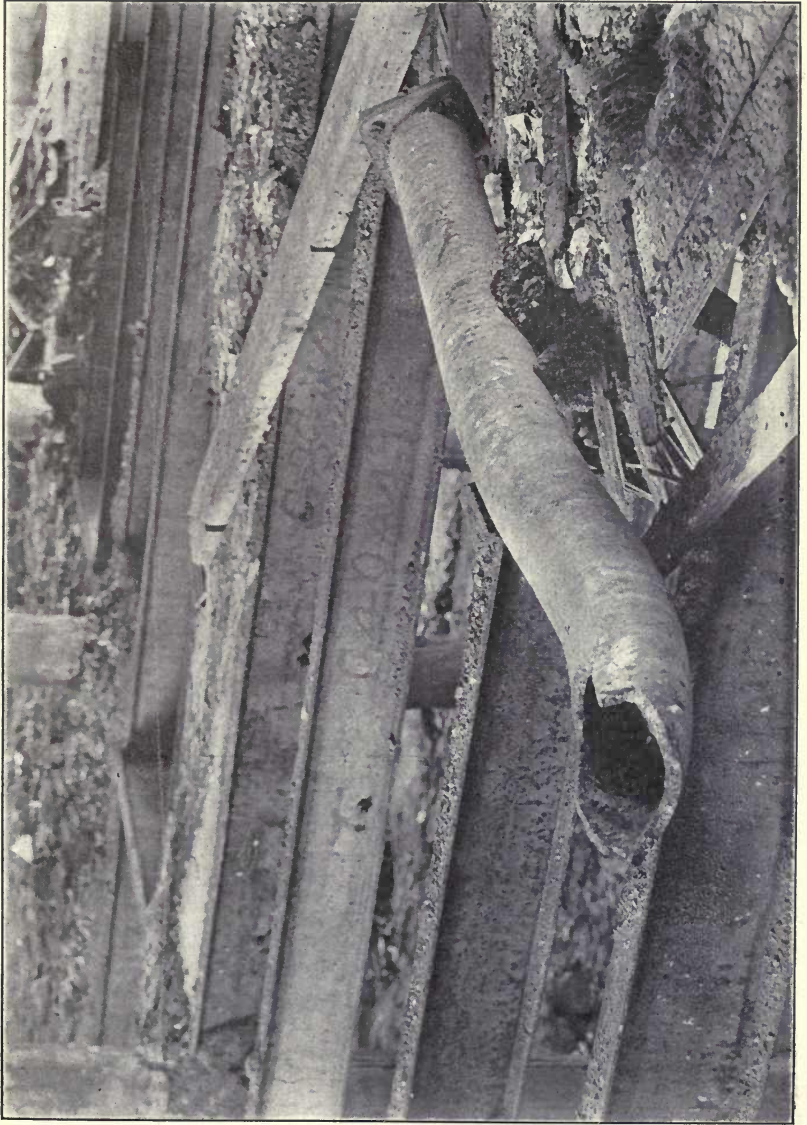
Collapsed Column (33 or 34), Showing Fracture and Deflection Due to Heat.

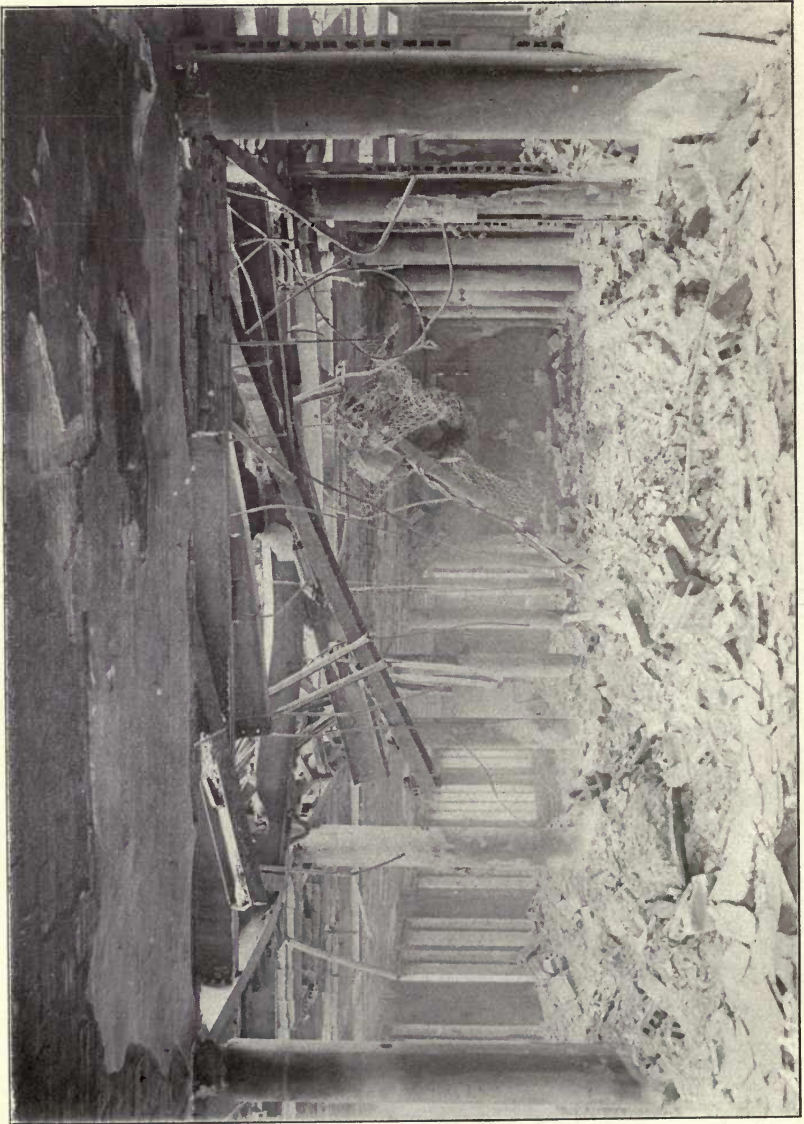
Three cylinder presses, a number of job presses and lighter machinery fell through several floors, but may have been carried down by the collapse of the two upper stories previously noted. One cylinder press broke through the eleventh floor in the rear, but did not fall through. Shafting fell from the ceiling to the floor in several stories.

TENTH STORY, Looking North, Showing Condition on Eleventh Floor on Account of Collapse of Columns 33 and 34. Cylinder Press Hanging in Eleventh Floor Shown in Rear.

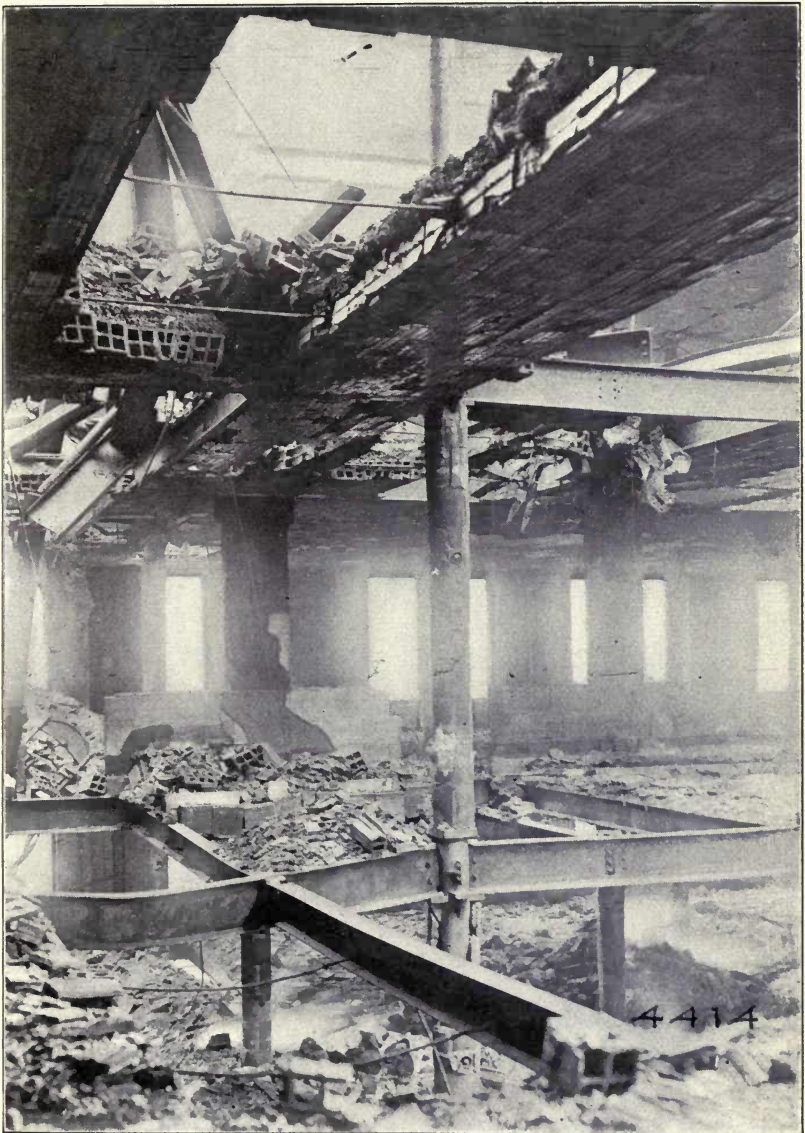
TENTH STORY, Looking North, Showing Damaged Beams, Collapsed Floor Arches, etc.

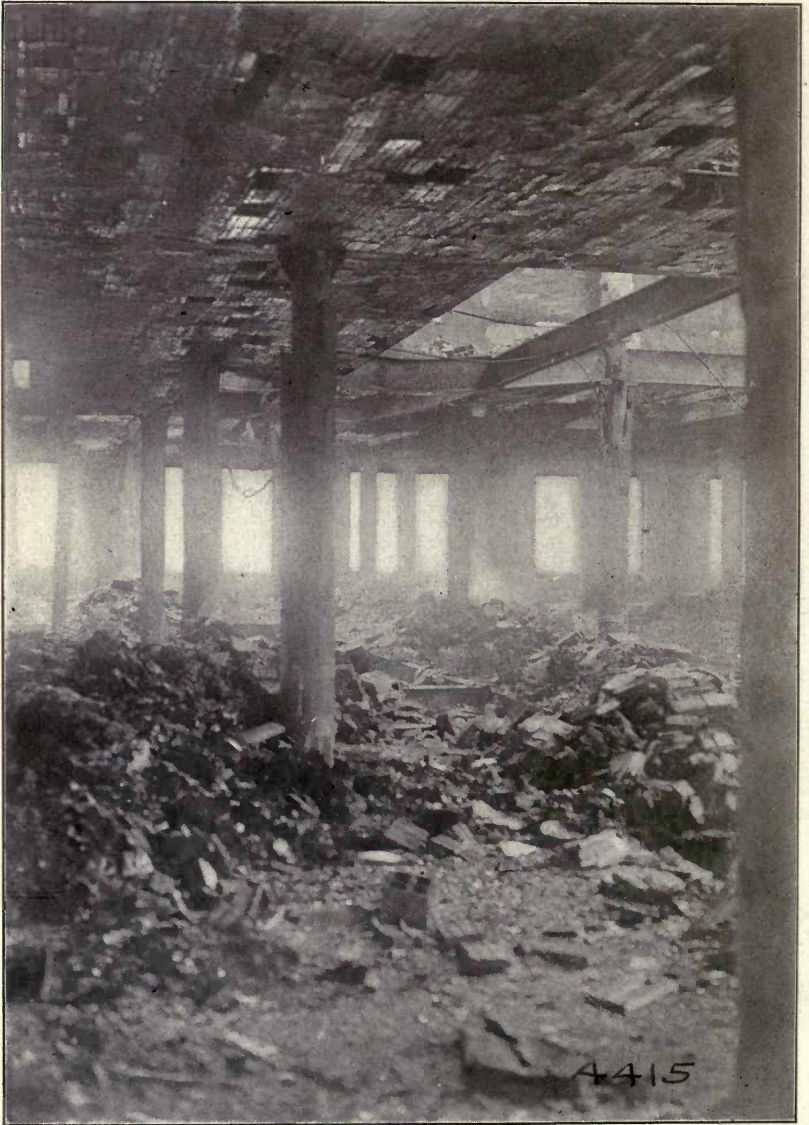
NINTH STORY, Looking North, Showing Damaged Soffits of Arches, Collapsed Arches, Deflected Beams, Damaged Column Covering, etc.

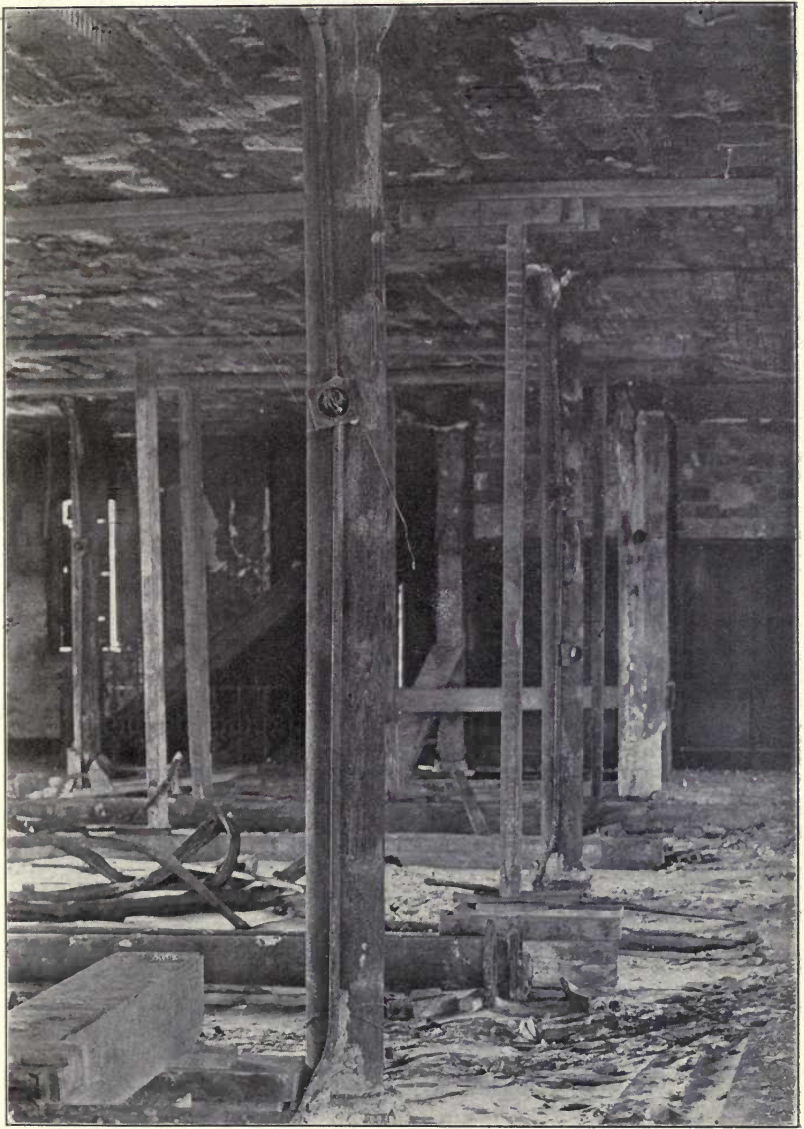
The ninth story section of column 25 was deflected by heat about one inch, but did not fail. Slight deflection was also noted in the eleventh story section of column 27. Examination shows that the sixth story section of column 45 was defective both in thickness and material. About twenty-five or thirty per cent. of the lugs on the columns next to the main collapsed portion, namely, Nos. 38, 44, 46 and 51, were more or less broken, the fracture being through one bolt hole in some and both bolt holes in others. The bolts were either sheared or the threads stripped.

NINTH STORY, Column 25 in the Foreground, Deflected about One Inch.

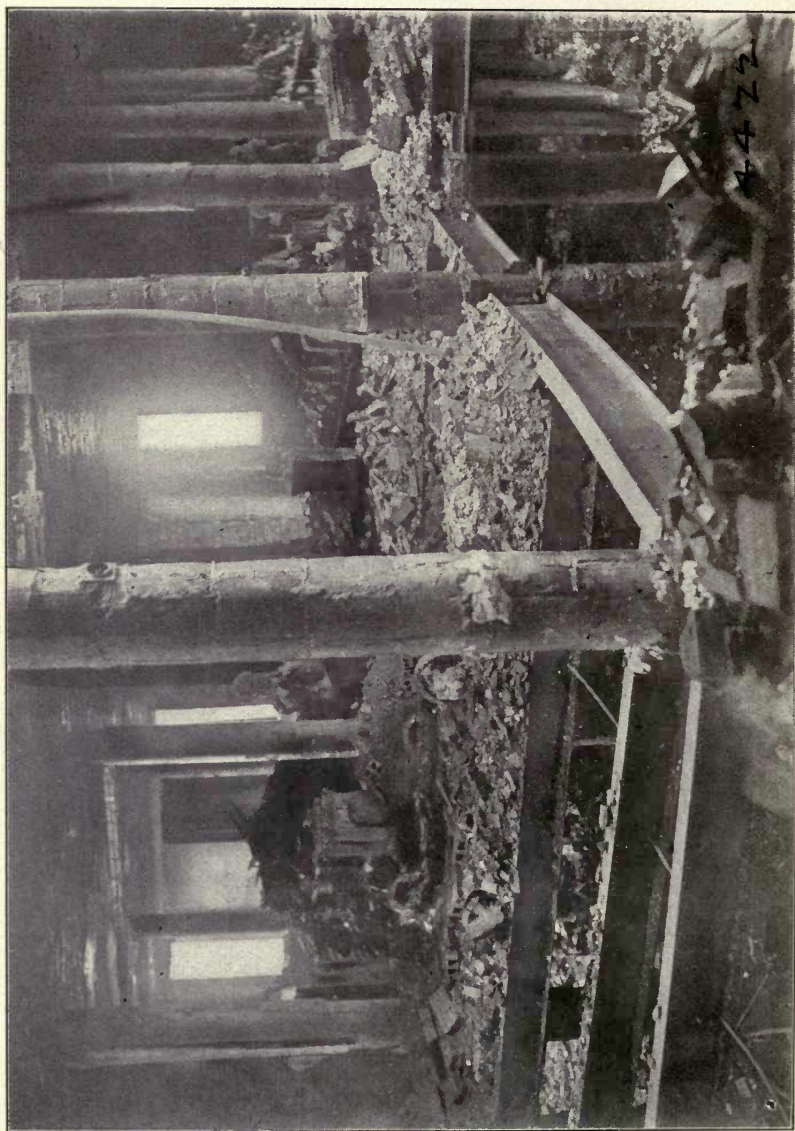
EIGHTH STORY, Looking Northeast, Showing Deflected Beams, Broken Lugs on Columns, etc.

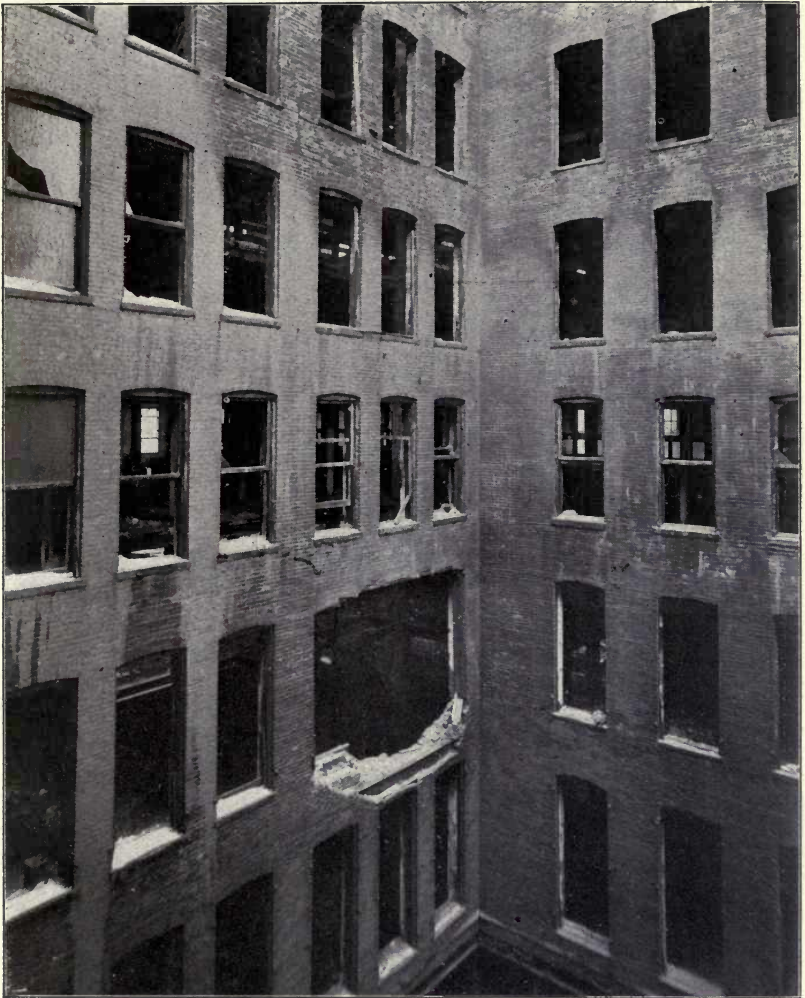
Rear of Building Overlooking One-Story Extension in Southeast Corner, Showing Window Mullions Knocked Out by Falling Material and Unprotected Window Openings in Angle Walls, through which Fire Communicated from Story to Story.

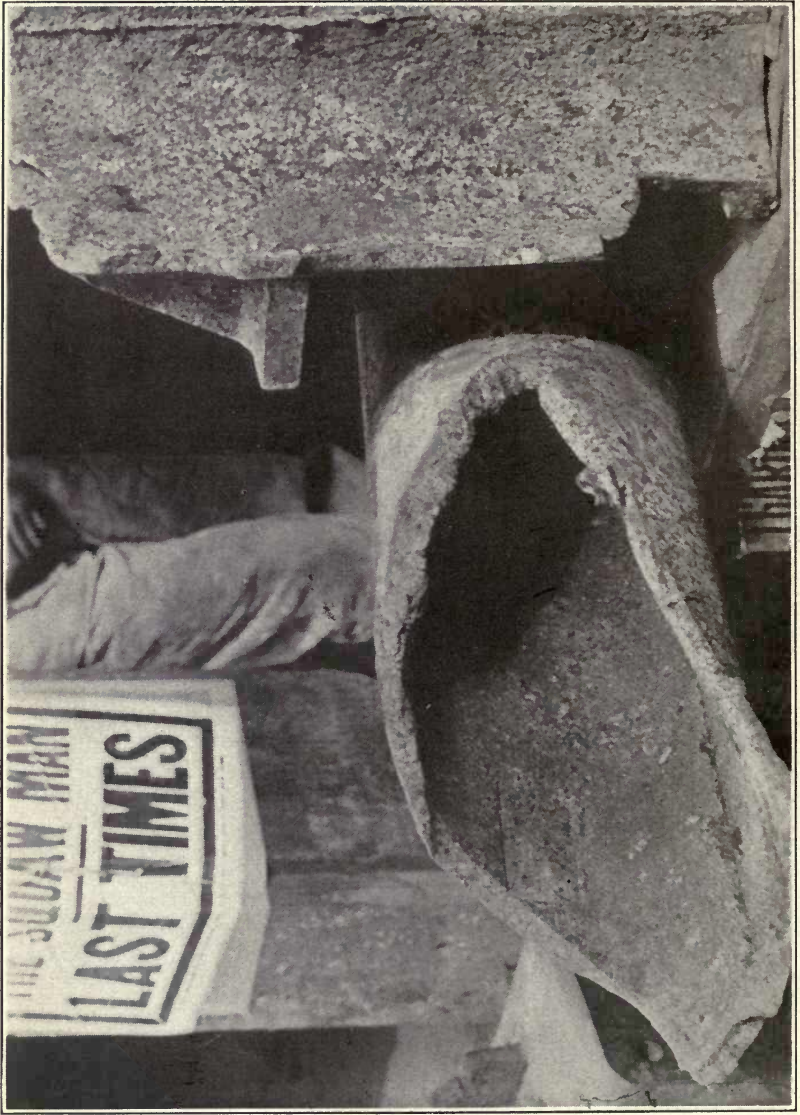
The failure of column 45 caused the collapse of a section approximately forty by twenty-four feet of all floors from roof to basement, located near the rear court. The ninth, tenth and twelfth story sections of this column were broken into two or more pieces in falling. (See floor plans and section.)

Column 45, Sixth Story, Showing Fracture, etc. The Failure of this Column Caused the Main Collapse.

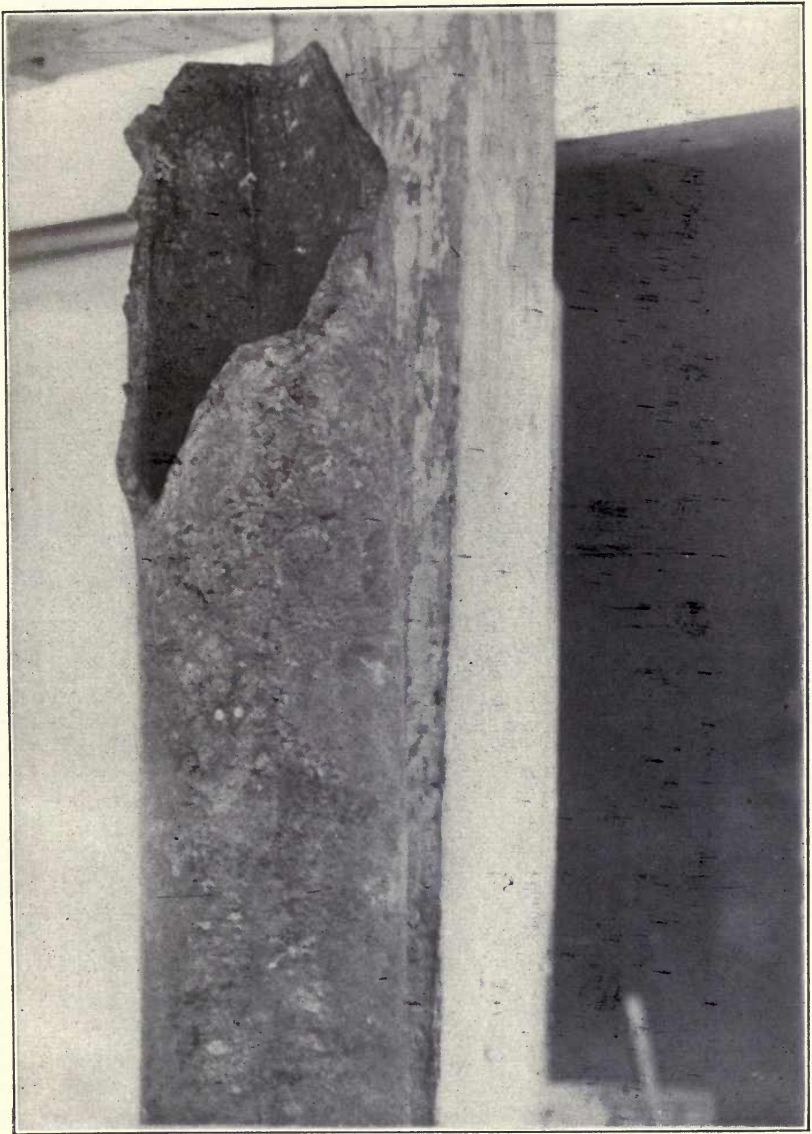
Column 45, Sixth Story, Showing Fracture; the Failure of this Column Caused the Main Collapse, the Break Occurring about 4'-0" Below the Seventh Floor Level.
